Re: Dairy Farmers of America, Cabool, MO

**UNSATISFACTORY FINDINGS  
RESPONSE REQUIRED**

**Missouri Department of Natural Resources  
Southeast Regional Office/Water Protection Program  
Report of Inspection  
Dairy Farmers of America, Cabool, MO  
950 Metrecal Trace Street/Cabool/Texas County  
MO-0002828  
July 31, 2019**

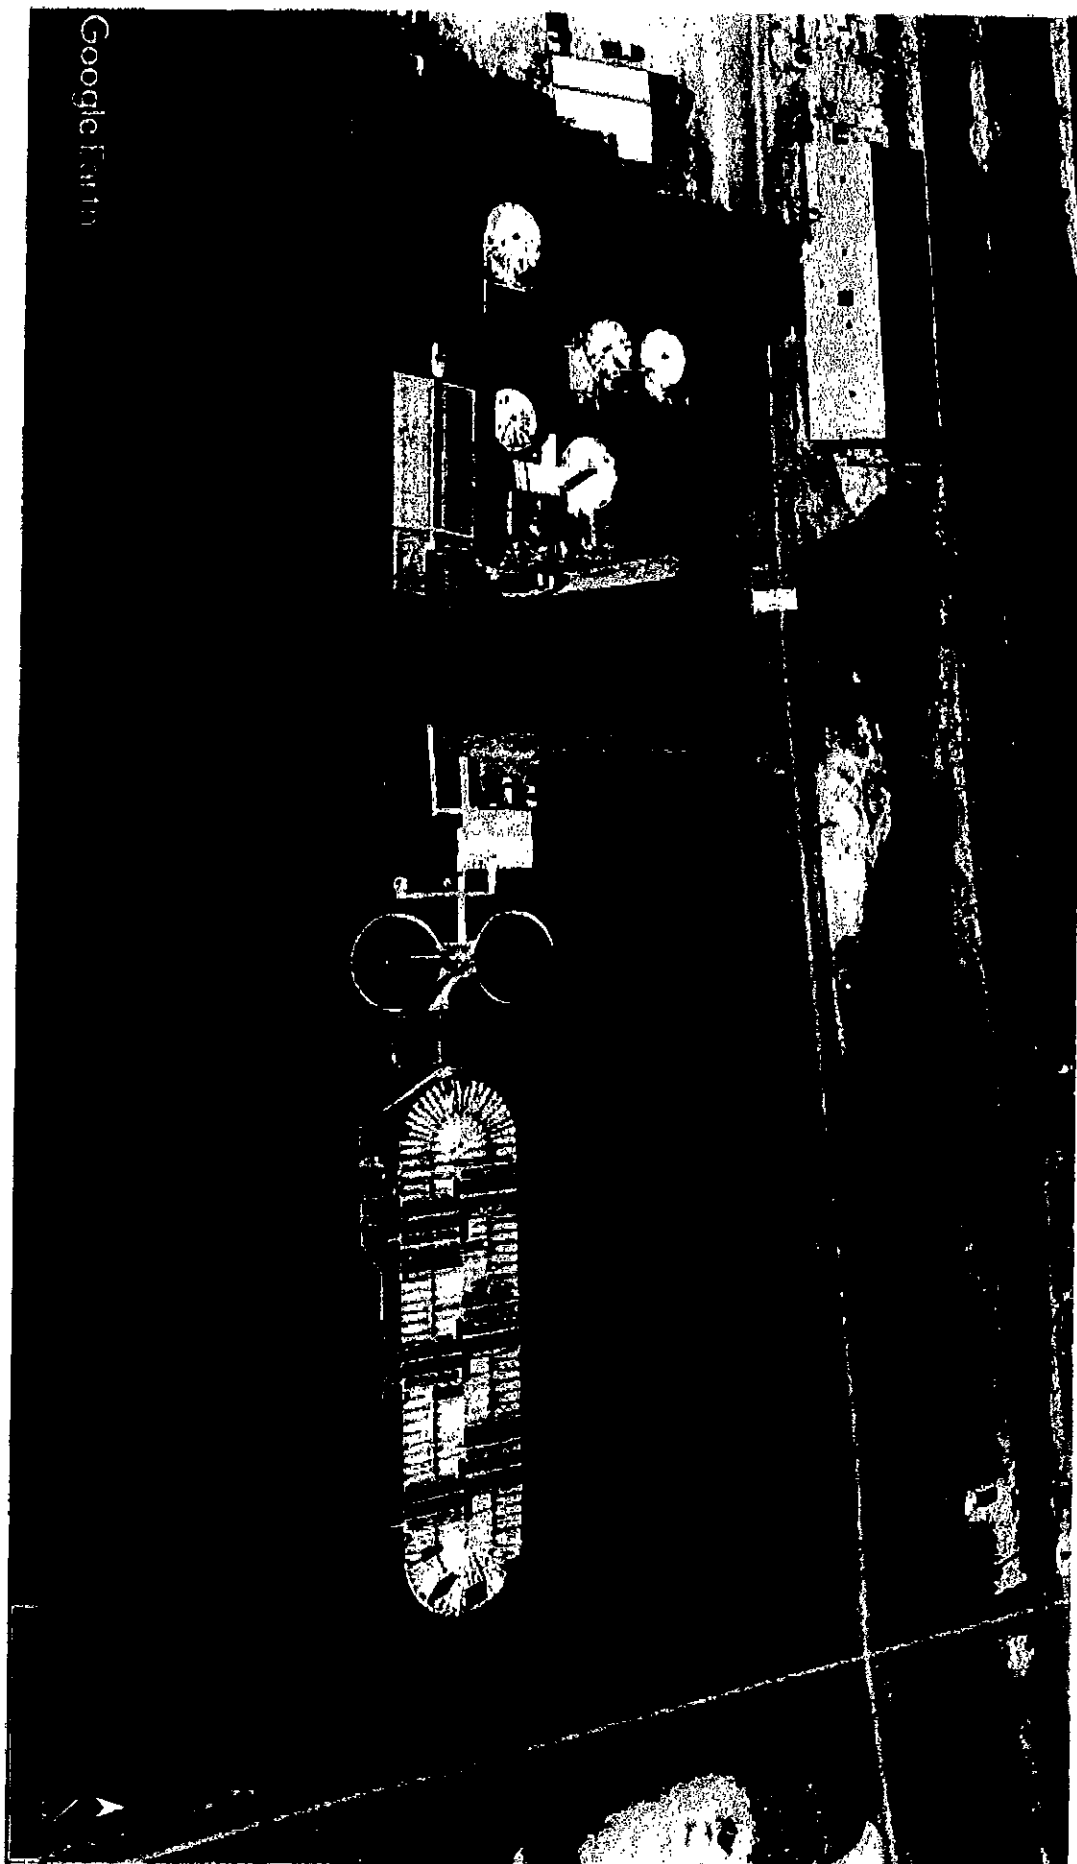
We thanked Mr. Riley and Mr. Collins for their time and assistance and then followed Mr. Henley to one of the land application fields. The site was fenced, the gate was locked, and it appeared to be well maintained. However, it was not marked as required by MSOP MO-0002828. According to Mr. Henley, not all of the sites listed on the permit are used and none of the sites used are marked. I recommended that sites without contracts should be removed from their permit and those still used must be marked.

**Description:** Land application field
